# Manhole Inspection Summary

Manhole # S4900\_014MH

Insp Date: **3/17/08 10:55 AM**

**Location** Address: **Greenview**

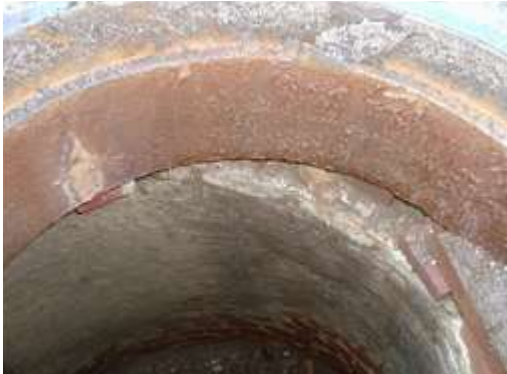
Defect 2

**Frame** Offset: **3** (in.) Condition: ☐ Sound ☐ Cracked ☒ **Leaks**

offset

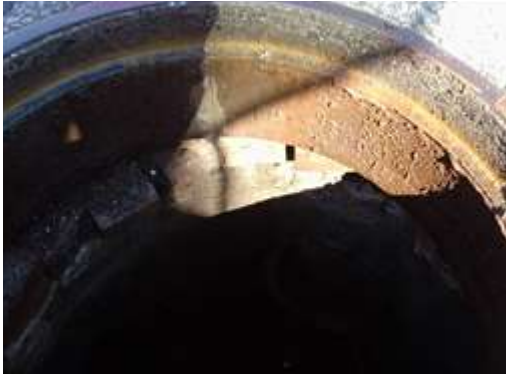
Defect 1

Condition: ☐ Sound ☐ Cracked ☐ Root Intrusion ☒ **Loose Brick** ☐ Deteriorated

Infiltration: ☐ None ☐ Joint ☐ Cracks ☒ **Mortar** ☐ Roots ☒ **Wall**

adjustment joint

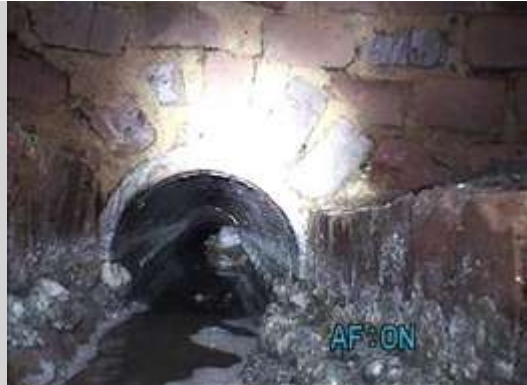
12 O'Clock Outflow

8 in. Circular Gravity Sewer  
Pipe Out @ 12 O'Clock

Pipe Height: **8.4** (in.) Rod and Bar (Angled)  
Pipe Material: **Clay** ☐ Pipe Lined  
Invert Depth: **6.80** (ft.) Flow Characteristics: **Fast**  
Deposits: ☒ None ☐ Mud ☐ Sludge ☐ Debris ☐ Grease  
Silt Depth: (in.) Deposits Extent:  
Infiltration: **None** Pipe Seal Cond: **Sound**

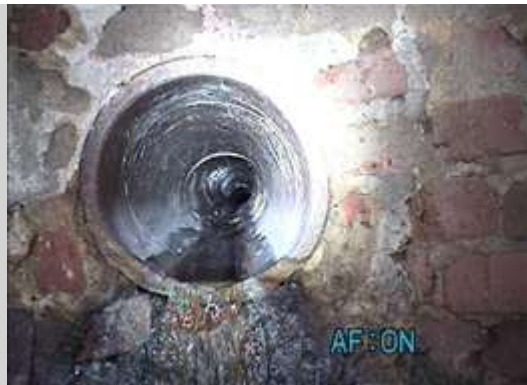
6 O'Clock Inflow

8 in. Circular Gravity Sewer  
Pipe In @ 6 O'Clock

Pipe Height: **8.4** (in.) Rod and Bar (Angled)  
Pipe Material: **Clay** ☐ Pipe Lined  
Invert Depth: **5.70** (ft.) Flow Characteristics: **Fast**  
Deposits: ☒ None ☐ Mud ☐ Sludge ☐ Debris ☐ Grease  
Silt Depth: (in.) Deposits Extent:  
Infiltration: **None** Pipe Seal Cond: **Sound**

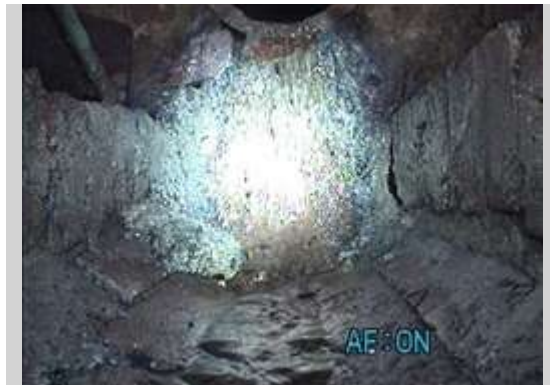
Drop In @ 6 O'Clock

Outside drop.

Drop: **Outside** Rod and Bar  
Angled: **Yes** Reading: **5.60** (ft.)  
Inv Depth: **6.60** (ft.)  
Drop Condition: **Open**
